Proposed Residential Development, Ardshanavooly,
Killarney, Co. Kerry

Stage 1 Road Safety Audit

January 2026

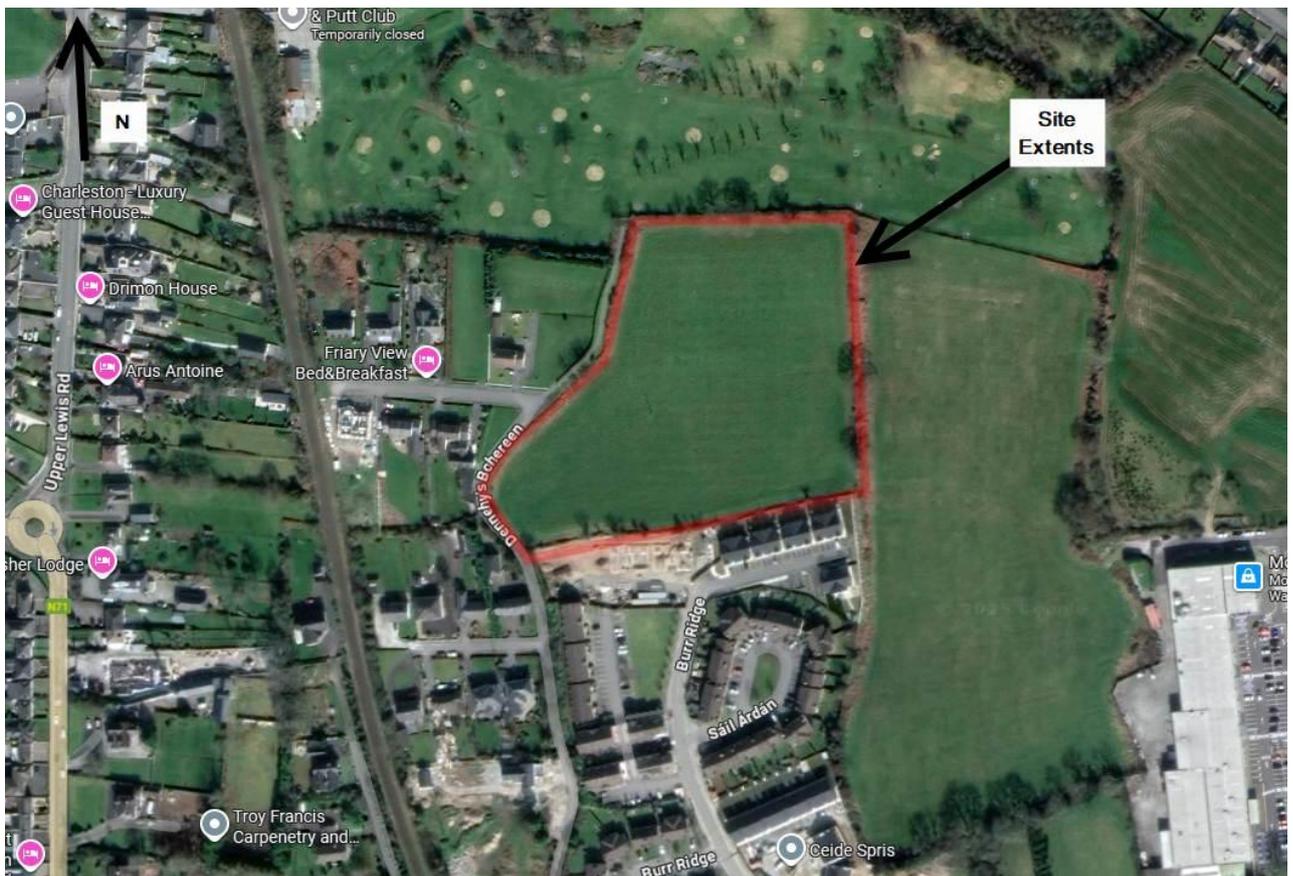
Figure 1.2 – Site Extents

The development is to be accessed via 1 number priority junction located within the 30kph Urban estate speed control. See Figure 1.1 Site Location Map. Figure 1.2 shows the site extents on aerial photography and Figure 1.3 shows the site layout for the proposed works.

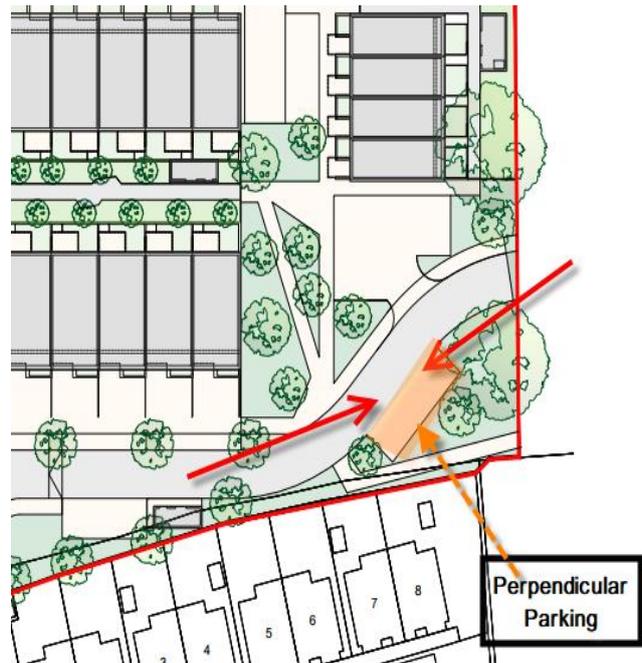
Figure 2.1

2.1. Problem: Connectivity to the development Lands to the east.

The site layout has made provision to show both a pedestrian and vehicle connection to the future development lands to the east at the south west corner. The design appear to show perpendicular parking along this section of the site on approach/receding from the horizontal road curve. The design guidelines including the forward visibility as set out in the Design Manual for Urban Road & Streets (DMURS) should be provided at this location and internally within the development. Inadequate forward visibility to these parking spaces may lead to collisions between vehicles passing by on estate road and vehicles exiting the parking spots. Refer to Fig 2.1

Recommendation 1

A parking arrangement with an adequate forward visibility envelope is required, in accordance with the relevant standards for the road design speed. The visibility envelope should be kept clear of all obstructions such as wall, hedges, fences, signs etc and vegetation over 600mm in height.

2.1	Y	Y	Layout revised to provide parallel parking in this location to overcome perpendicular parking sightlines issue. Drawing reference 10029 Ardshanavooly - 1003 - 02 - Site Layout Plan

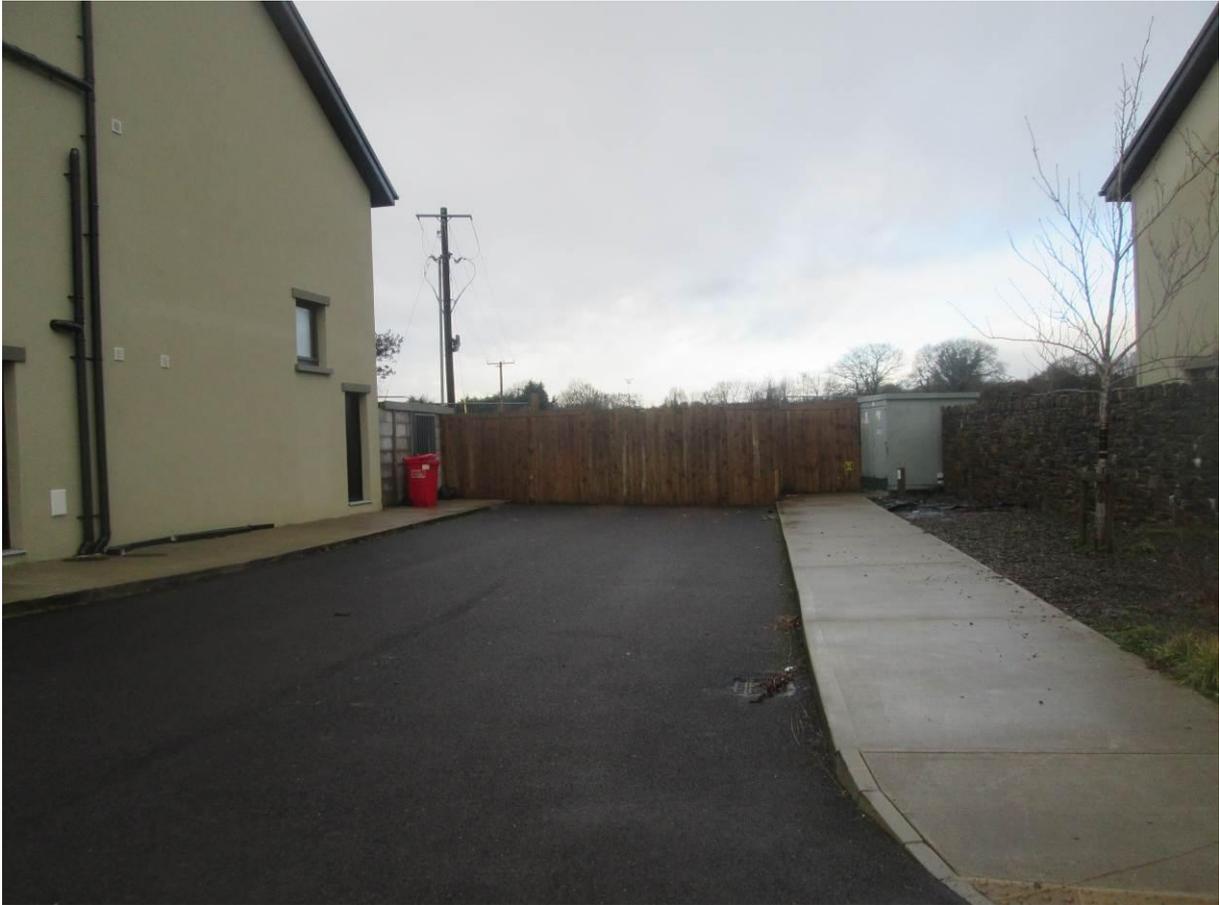
Photo A1 – Entrance to proposed Estate

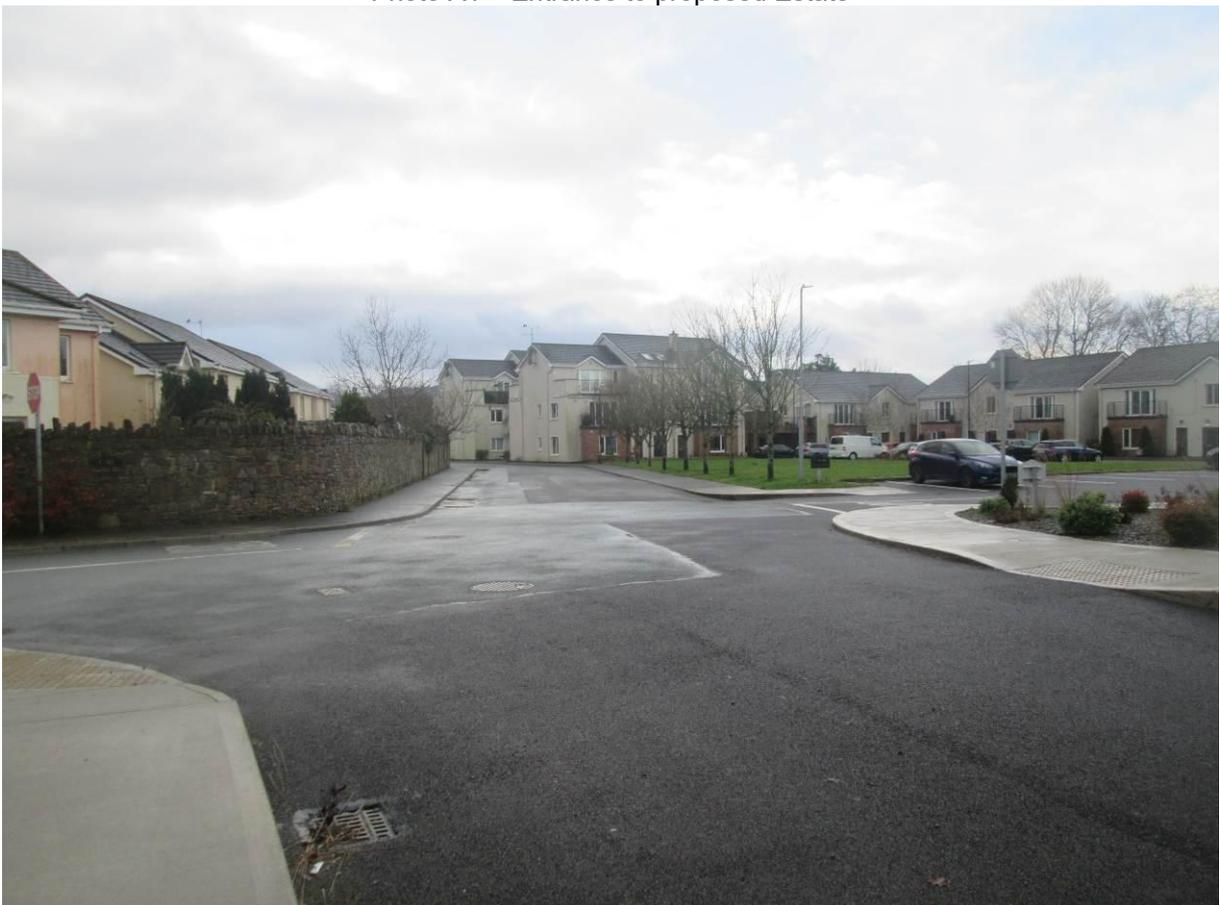
Photo A2 – Access road through exiting residential development to proposed subject site
